Comparison of Methods of Bump Bonded Modules Diagnostics

These methods were applied to recently delivered batch of RTI bump bonded modules with PSI46v2 Read Out Chips (ROC). We concentrated on one module RTI_2x4 #2 X-rayed at the corners as shown on Fig.1

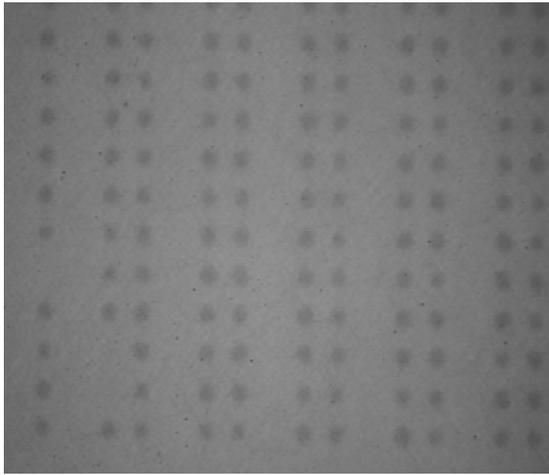
ROC 0 (7,5B)

The X-ray pictures are shown in Fig 2 for four corners scanned. One of four corners scanned has three missed bumps on it, and others are apparently good. Note that from previous studies we know that the possible defects of bump bonding are concentrated on the periphery of the module: edges and corners.

Fig.2 X-ray images of the corners of the chip. Missed bonds are evident on the ROC0

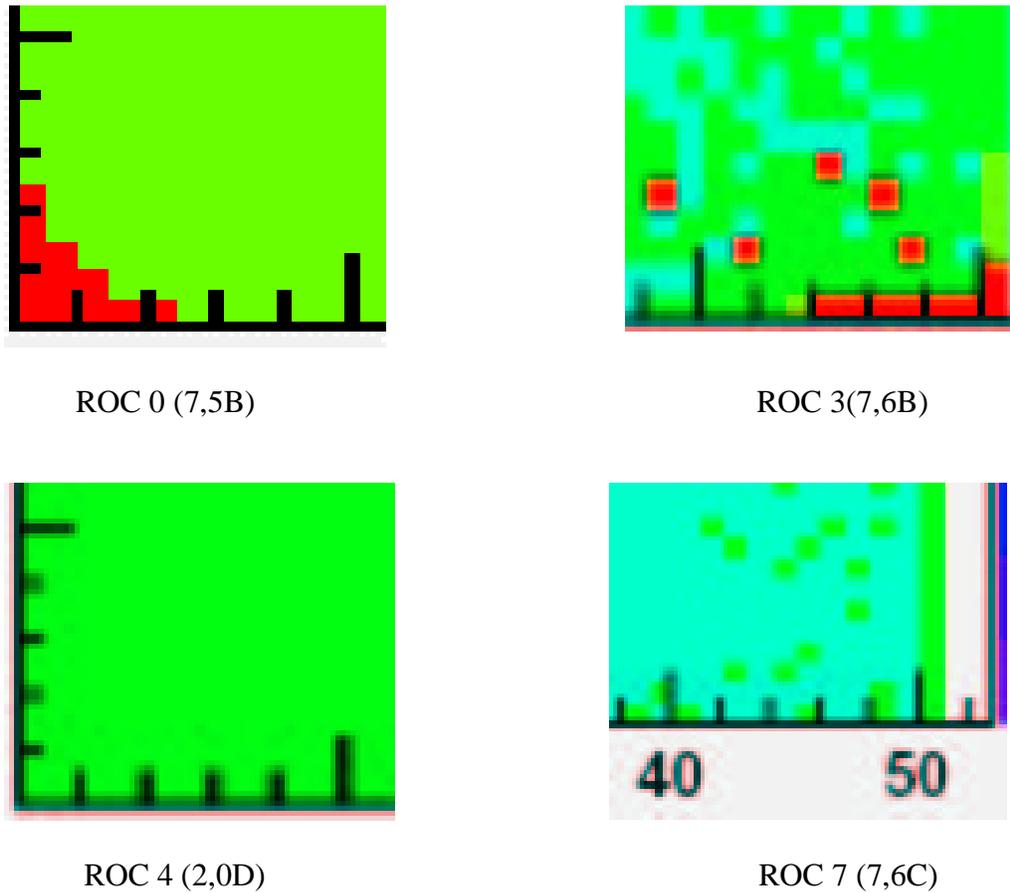
Electronic test of bump bonded modules was developed at the ETHZ (Test D described in U. Langenegger et al, PSI Pixel Meeting, 27.05.2005). The idea is to see response of the ROC pixel preamplifier to leakage current of the sensor. When the amplifier is set to the highest sensitivity, the leakage current saturates it if the amplifier input is connected to the sensor. To the opposite, if the amplifier input is connected with the open (“bad”) bond it will be not saturated. This method was verified at PSI and now we are cross checking it. The measurements were made at sensor bias voltage of $-250V$. The results are shown in Fig 3 for four corners of four X-rayed chips. Red colored pixels are diagnosed as “bad”. Comparing with X-ray pictures we see that there are much more “bad” pixels than missing bump bonds in Fig. 1. Note, on the ROC 0 having 3 missing bonds are positioned in agreement with observations of “bad” bonds with the Test D. Other chips have no missing bumps on X-ray image nonetheless we found several missed bonds during electrical test on the chip 3.

Fig. 3 Results of the Test D for X-ray-ed corners of the ROCs. ROC 0 and ROC 3 have much more bad bonds that it is seen at X-ray images. ROC 4 and 7 has no bad bonds.

Test D says that there is no direct current contact between the bump and sensor("cold solder") but only a small capacitance. Perhaps a transient pulse at the sensor pad may sometimes induce a signal at the preamp by capacitive coupling across the "open" bump. Another possibility is the counts result from some cross talk between pixels. Neighbor hits can be generated by big depositions of charge on the active pixels.

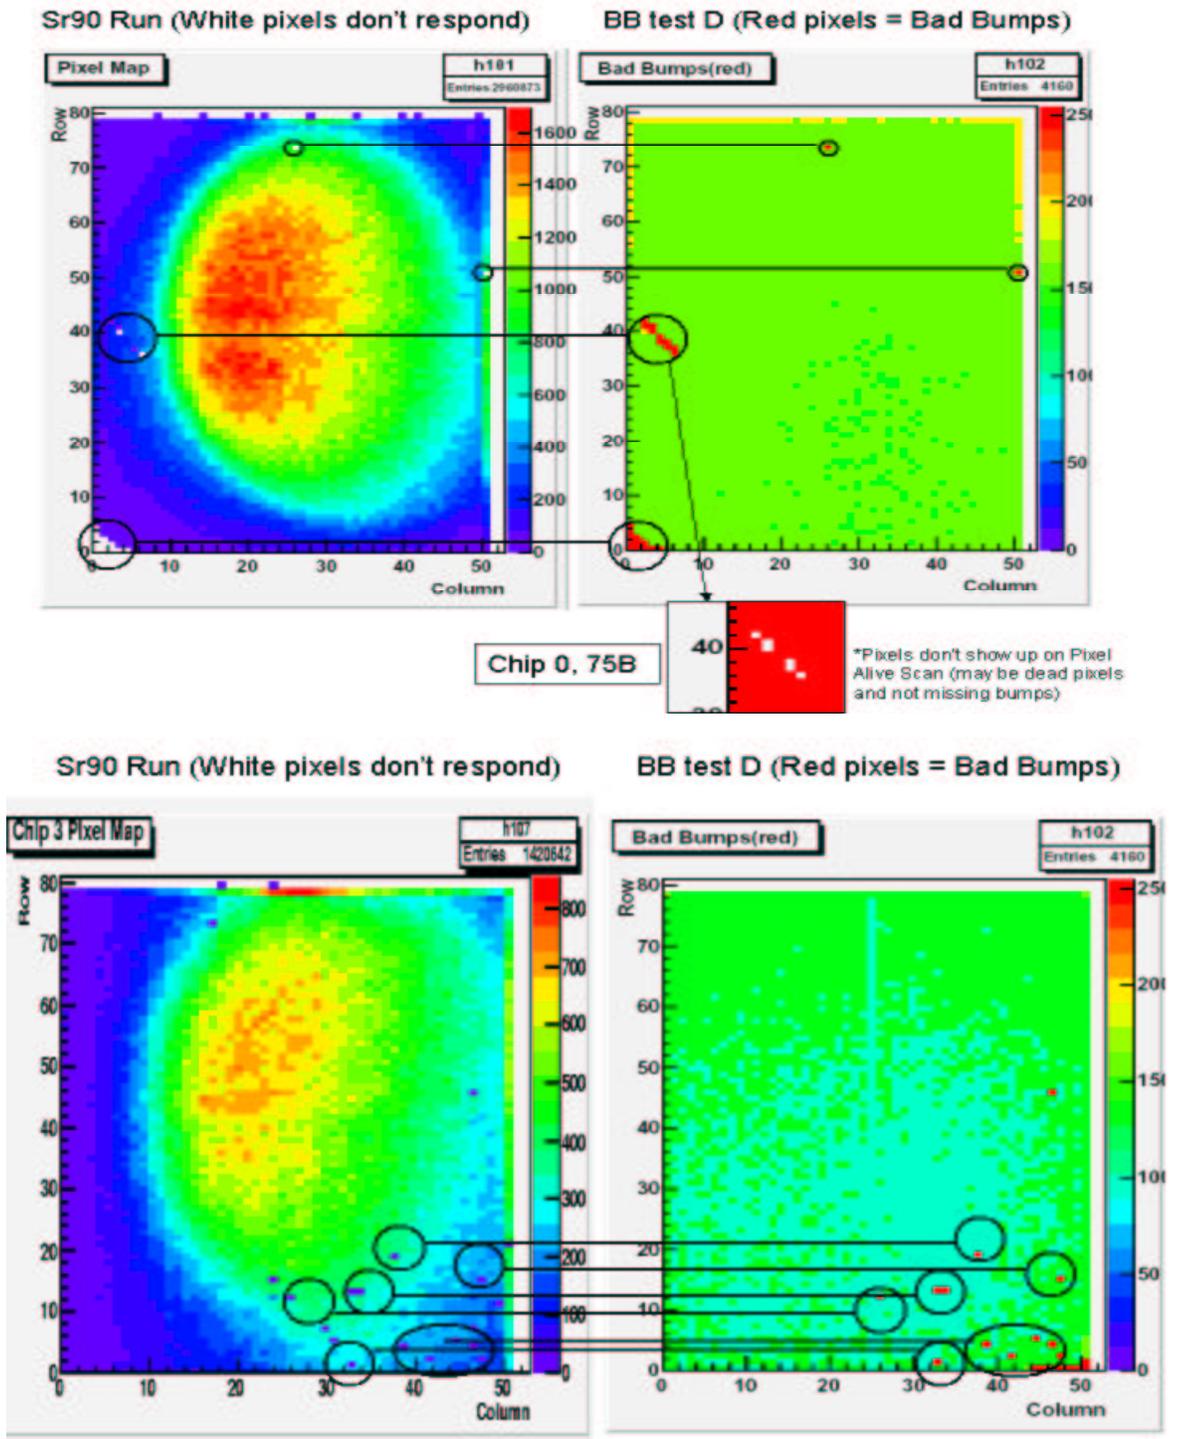
ROC 3(7,6B)

Further verification of the procedure was made using a radioactive source. In Fig. 4 results of the radioactive source irradiation (number of hits in each pixel) are shown together with results of the Test D for full area of ROCs 0 and 3. Comparing these results, we see that there is general agreement between the electronic and the source tests; i.e., the three bumps missing on the X-ray photo are also missing with the

source test. However, not all of the "missed pixels found in electronic test D give no signal with the radioactive source. Many of them do show signals, but with a very low counting rate (low efficiency) compared to their neighbors.

A more enigmatic situation is found in the comparison shown in the inset of Fig. 4, chip 0. There are 6 pixels (white squares) that were found to be inoperative during "alive" pixel functionality test after bonding before the "missing" bond test D was made. These failures have nothing to do with the bump bonds; the failures must be in the pixel preamplifier or charge injection system itself. Yet after being bonded to a sensor, some of them exhibit signals under irradiation (again with low efficiency), as can be seen in Fig. 4, where the corresponding pixels are not all white (inoperative). It might point to the cross talk contribution discussed above.

Fig. 4 Full image of ROC 0 and 3 pixel with radioactive source and the electronics Test D. Correlation between two tests is evident.

Overall the quality of the bonding is good. Out of two bump bonded chips fully tested we found 20 (16) “missed” bonds on the ROC 0 with electronics (radioactive) scan and 20 (12) “missed” bonds on the ROC 3. It is about 0.5% of all channels.
