Comparison of Methods of Bump Bonded Modules Diagnostics

These methods were applied to recently delivered batch of RTI bump bonded modules with PSI46v2 Read Out Chips (ROC). We concentrated on one module RTI_2x4 #2 X-rayed at the corners as shown on Fig.1

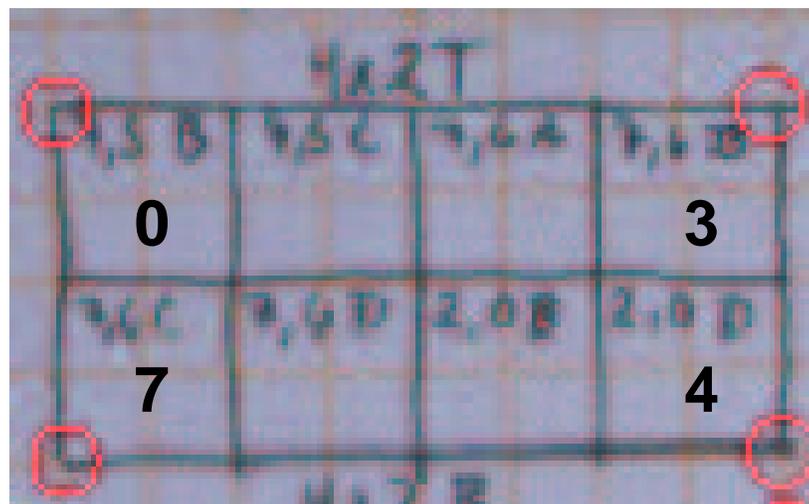
Fig. 1 A scheme of the bump bonded device under test. Areas of X-ray scanned corners are shown. The numbers 0-7 are showing the readout chip positions on the VHDI test board. Indexes 7,5B 7,5C and so on are showing ROC ID. These ID are used to check individual ROC test data.
